TOV Effects on Surge-Protective Devices

Reprinted from *Conference Record, Power Quality Exhibition and Conference*, Baltimore, October 25-27

TOV EFFECTS ON SURGE-PROTECTIVE DEVICES

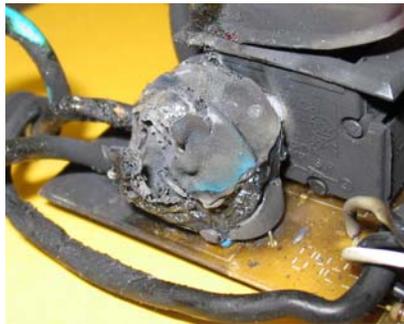
Figure 1
Crispy Factor CF3, indicating obliteration

Post mortem examination of the test specimens included measurements of the characteristics of the SPD components as well as a visual inspection for which a short-hand description was created here. While it is doubtful that these terms will become official IEEE or IEC definitions, they will suffice for the purpose of tersely describing the condition of the MOV in the tabulations of this paper, Figures 1 through 4 show the extent of MOV damage from extreme to benign.

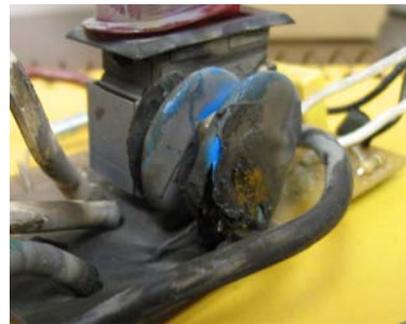
Figure 2
Crispy Factor CF2, indicating a flaky surface and some loss of physical structure

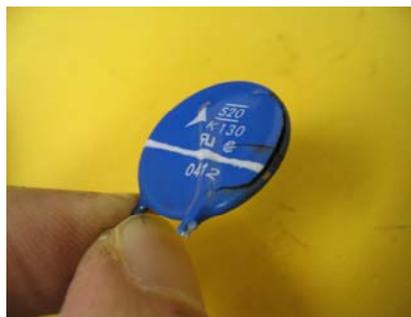
Figure 3
Crispy Factor CF1, indicating a single split or hole

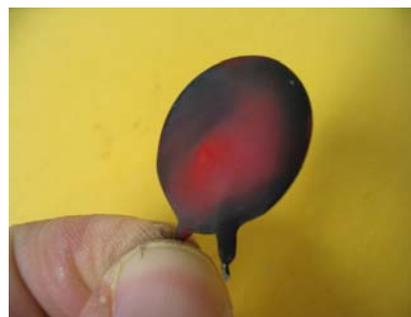
Figure 4
Crispy Factor CF0, indicating an intact MOV covered with soot from other MOVs
